**Flood Control Project Maintenance  
Levee Inspections**  
**LMA District Cover Sheet**  
**Spring 2017 Levee Inspection Results**

**Sacramento Maintenance Yard Maintenance Area 0009**

Waterway			Bank	Unit Miles
Unit No. 01 Sacramento River			Left	19.35
	Spring (March - May)	Summer (June - August)	(September - November) Fall	Winter (December - February)
Unit Maintenance Rating (Fall Only)				
Date of Inspection	4/25/2017 - 4/26/2017			
DWR Inspector	Zach Jojola			
Accompanied By	Dave Williams Sacramento Maintenance Yard

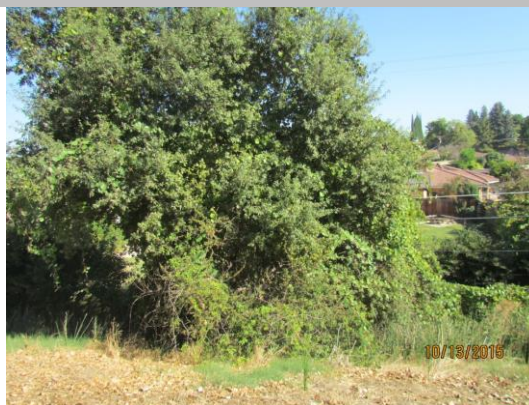
Photo 2 of 2 : SP\_2017\_MA0009\_201\_296\_20170320\_00215.jpg

LM Start	<b>1.70</b>	Rating **	M	Issue No.	<b>296 (cont)</b>
LM End	<b>1.70</b>	Issue Type +	Ma	Location *	LS

View of the tree on the landward side of the levee. Fall 2015.

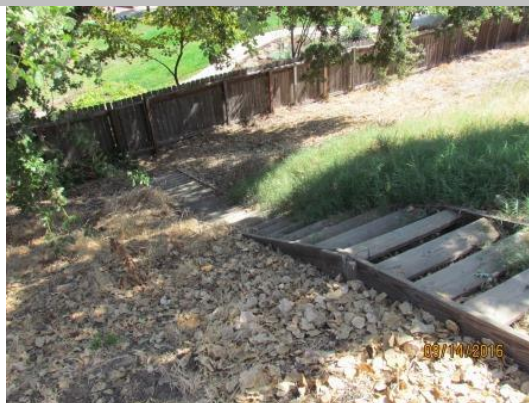
Photo 1 of 2 : SP\_2017\_MA0009\_201\_239\_20170320\_00181.jpg

LM Start	1.73	Rating **	M	Issue No.	239
LM End	1.73	Issue Type +	En	Location *	LS
Category	Earthen Levee			GPS Latitude/Longitude	
				Start	End
Item	Encroachments			38.524346 °	38.524346 °
				-121.524854 °	-121.524854 °
DWR ID	DWR_MA0009_01_f_2016_239				
Comment Code					
ST : Stairway					
Inspector Comment

Old wooden stairway on landside. Fall 2016 inspection.

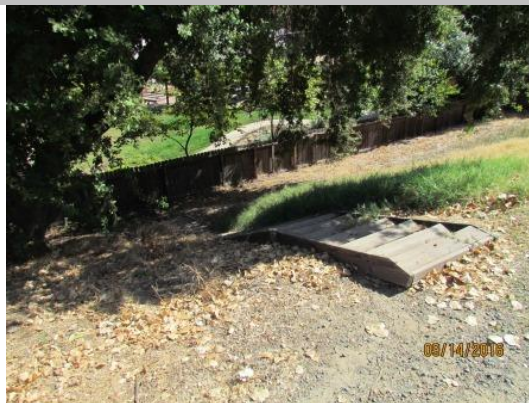
Photo 2 of 2 : SP\_2017\_MA0009\_201\_239\_20170320\_00182.jpg

LM Start	1.73	Rating **	M	Issue No.	239 (cont)	
LM End	1.73	Issue Type +	En	Location *	LS	
Category	Earthen Levee			GPS Latitude/Longitude		
				Start		End
Item	Encroachments			38.524346 °		38.524346 °
				-121.524854 °		-121.524854 °
DWR ID	DWR_MA0009_01_f_2016_239					
Comment Code						
ST : Stairway						
Inspector Comment

Old wooden stairway on landside. Fall 2016 inspection.

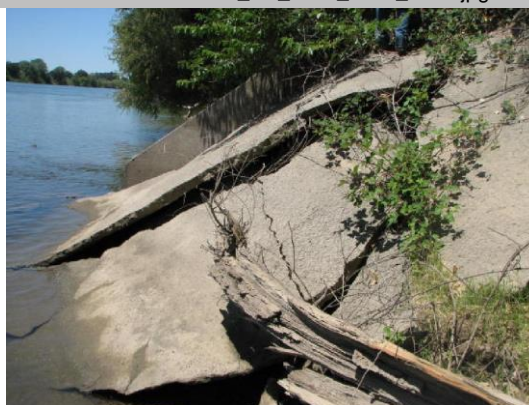
Photo 1 of 3 : UCIP\_SP\_2017\_4703\_6128.jpg

LM Start	1.82	Rating **	M	Issue No.	1786
LM End	1.82	Issue Type +	En	Location *	LS
Category	Supplemental			GPS Latitude/Longitude	
				Start	End
Item	DWR UCIP Field Study			38.523360 °	38.523360 °
				-121.523660 °	-121.523660 °
DWR ID					
Comment Code					
Inspector Comment					
FS_ID:4703 DS_ID:17408 EP_NO: 5304A Repair Type: Non-Urgent Crossing Status: Found UCIP Comments: Concrete around outlet broken up on both downstream and upstream side of outlet. Needs some repairs to prevent further damage. FIELD_STRUCT_DESC: 8-foot by 8-foot reinforced concrete box culvert through the levee, 28.9 feet below the crown pumps at 35th Avenue sewage treatment plant. Concrete gate riser box on the waterward shoulder. Concrete headwall and flap gate on the waterward end (Permit No. 5304). FS Date: 6/19/2012 2:20:32 PM

Broken up concrete apron on downstream side of outlet

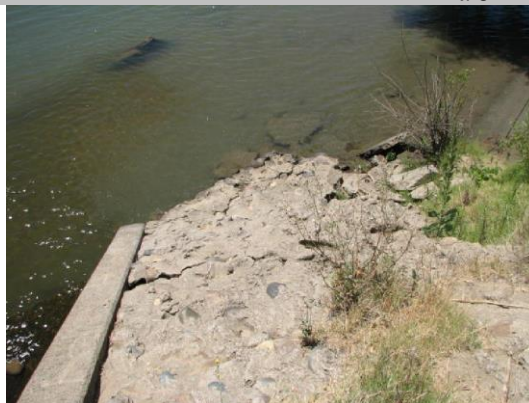
Photo 2 of 3 : UCIP\_SP\_2017\_4703\_6127.jpg

LM Start	1.82	Rating **	M	Issue No.	1786 (cont)
LM End	1.82	Issue Type +	En	Location *	LS
Category	Supplemental			GPS Latitude/Longitude	
				Start	End
Item	DWR UCIP Field Study			38.523360 °	38.523360 °
				-121.523660 °	-121.523660 °
DWR ID					
Comment Code					
Inspector Comment					
FS_ID:4703 DS_ID:17408 EP_NO: 5304A Repair Type: Non-Urgent Crossing Status: Found UCIP Comments: Concrete around outlet broken up on both downstream and upstream side of outlet. Needs some repairs to prevent further damage. FIELD_STRUCT_DESC: 8-foot by 8-foot reinforced concrete box culvert through the levee, 28.9 feet below the crown pumps at 35th Avenue sewage treatment plant. Concrete gate riser box on the waterward shoulder. Concrete headwall and flap gate on the waterward end (Permit No. 5304). FS Date: 6/19/2012 2:20:32 PM

Broken up concrete apron on upstream side of outlet

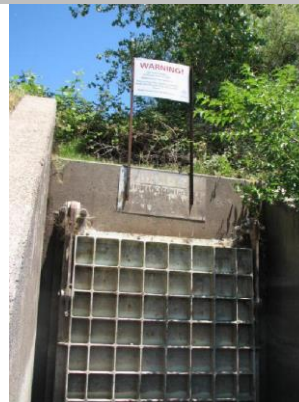
Photo 3 of 3 : UCIP\_SP\_2017\_4703\_6126.jpg

LM Start	<b>1.82</b>	Rating **	M	Issue No.	<b>1786 (cont)</b>
LM End	<b>1.82</b>	Issue Type +	En	Location *	LS

Flap Gate

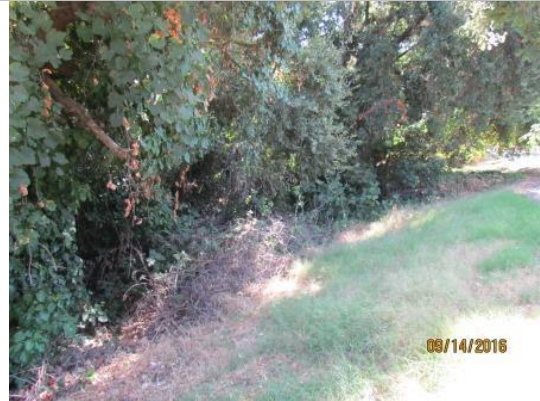
Photo 1 of 2 : SP\_2017\_MA0009\_201\_41\_20170320\_00035.jpg

LM Start	1.87	Rating **	M	Issue No.	41
LM End	1.90	Issue Type +	En	Location *	LS
Category	Earthen Levee			GPS Latitude/Longitude	
				Start	End
Item	Vegetation			38.522864 °	38.522507 °
				-121.523062 °	-121.522667 °
DWR ID	DWR_MA0009_01_s_2012_41				
Comment Code					
V6 : Landscaping					
Inspector Comment					
Trees need to be thinned and trimmed for visibility.

Trees on landward side of the levee. Lack of visibility. Fall 2016 inspection.

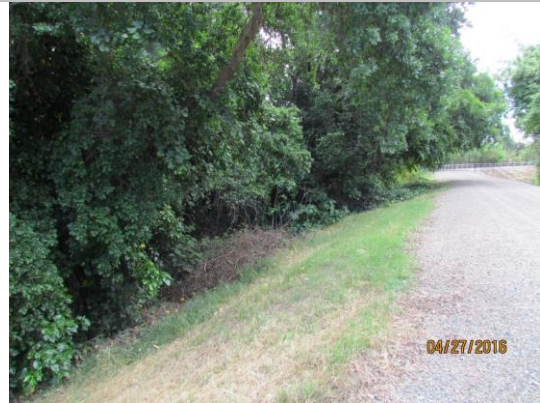
Photo 2 of 2 : SP\_2017\_MA0009\_201\_41\_20170320\_00036.jpg

View of the trees blocking visibility on the landward side looking downstream. Spring 2016.

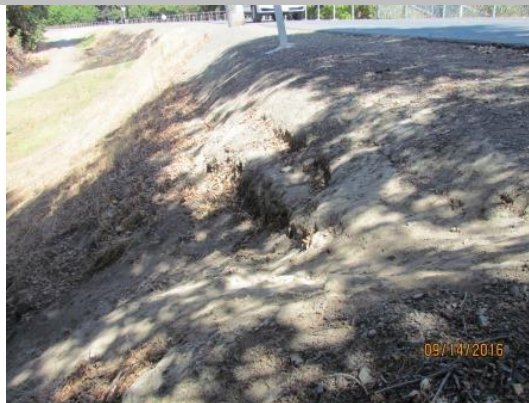
Photo 1 of 3 : SP\_2017\_MA0009\_201\_317\_20170320\_00235.jpg

LM Start	2.01	Rating **	M	Issue No.	317
LM End	2.01	Issue Type +	Ma	Location *	WS
Category	Earthen Levee			GPS Latitude/Longitude	
				Start	End
Item	Slope Stability			38.520972 °	38.520972 °
				-121.522747 °	-121.522747 °
DWR ID	DWR_MA0009_01_f_2015_317				
Comment Code					
S2 : Repair the levee slope damaged by foot traffic and prevent access where possible.					
Inspector Comment

View of the slope with slope stability issue. Waterward side. Fall 2016 inspection.

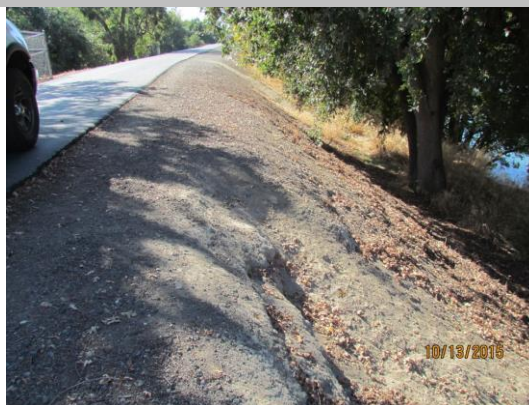
Photo 2 of 3 : SP\_2017\_MA0009\_201\_317\_20170320\_00236.jpg

Perspective view of the slope on the waterward side of the levee looking downstream. Fall 2015.

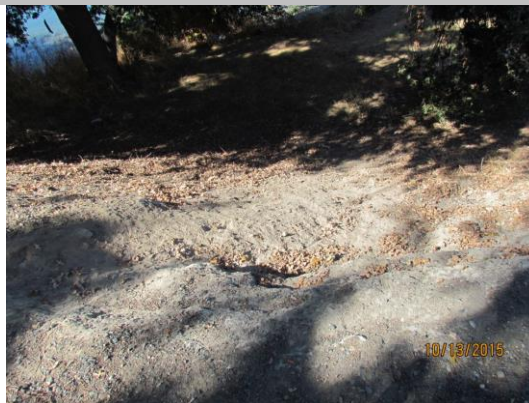
Photo 3 of 3 : SP\_2017\_MA0009\_201\_317\_20170320\_00237.jpg

View of the slope stability on the waterward side of the levee. Fall 2015.

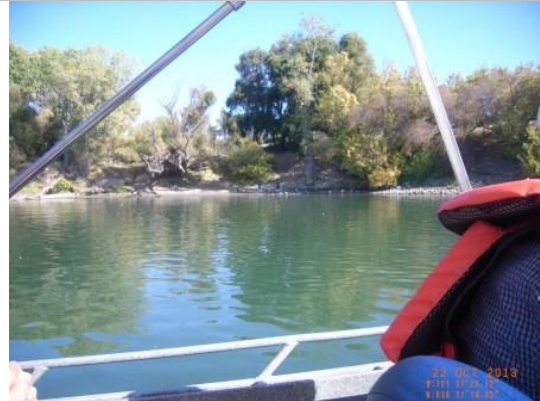
Photo 1 of 1 : SP\_2017\_MA0009\_201\_17\_20170320\_00019.jpg

LM Start	2.02	Rating **	M	Issue No.	17
LM End	2.05	Issue Type +	Ma	Location *	WS
Category	Supplemental			GPS Latitude/Longitude	
				Start	End
Item	2015 USACE Erosion Survey, DRAFT			38.520996 °	38.520606 °
				-121.523072 °	-121.523261 °
DWR ID	DWR_MA0009_01_s_2016_17				
Comment Code					
Inspector Comment					
2011 - Erosion into upper and lower slope. There has been significant scour around the tree roots. 2015: No observed changes. [2015 Site ID: SAC_53-8_L]

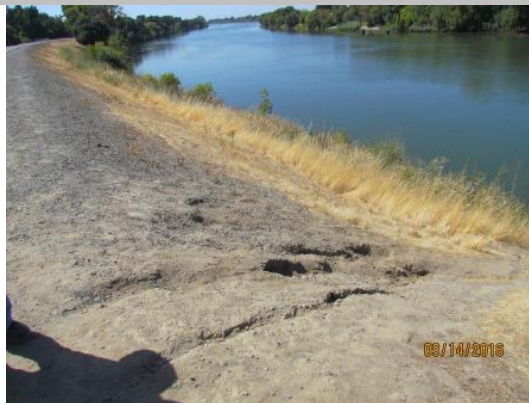
Photo 1 of 1 : SP\_2017\_MA0009\_201\_243\_20170320\_00187.jpg

LM Start	2.28	Rating **	M	Issue No.	243
LM End	2.28	Issue Type +	Ma	Location *	WS
Category	Earthen Levee			GPS Latitude/Longitude	
				Start	End
Item	Erosion / Bank Caving			38.517942 °	38.517942 °
				-121.525612 °	-121.525612 °
DWR ID	DWR_MA0009_01_f_2016_243				
Comment Code					
E2 : Schedule repair of erosion site prior to the next inspection.					
Inspector Comment

View of erosion site on waterward slope of the levee. Fall 2016 inspection.

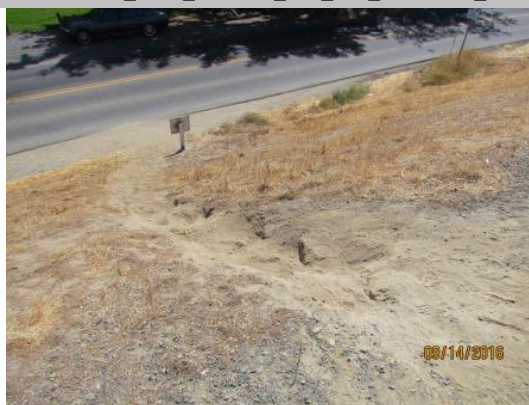
Photo 1 of 1 : SP\_2017\_MA0009\_201\_244\_20170320\_00188.jpg

LM Start	2.30	Rating **	M	Issue No.	244
LM End	2.30	Issue Type +	Ma	Location *	LS
Category	Earthen Levee			GPS Latitude/Longitude	
				Start	End
Item	Slope Stability			38.517755 °	38.517755 °
				-121.525941 °	-121.525941 °
DWR ID	DWR_MA0009_01_f_2016_244				
Comment Code					
S2 : Repair the levee slope damaged by foot traffic and prevent access where possible.					
Inspector Comment

Foot path on landside slope of the levee. Fall 2016 inspection.

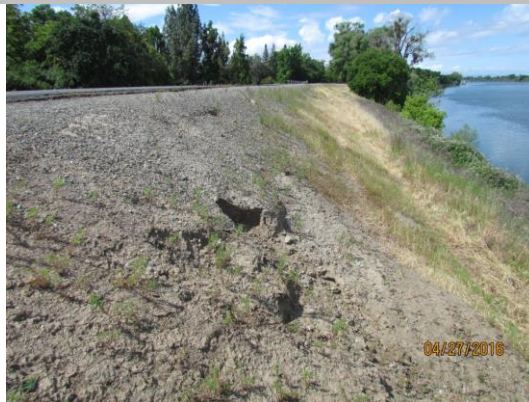
Photo 1 of 1 : SP\_2017\_MA0009\_201\_322\_20170320\_00241.jpg

LM Start	2.33	Rating **	M	Issue No.	322
LM End	2.33	Issue Type +	Ma	Location *	WS
Category	Earthen Levee			GPS Latitude/Longitude	
				Start	End
Item	Slope Stability			38.517526 °	38.517526 °
				-121.526431 °	-121.526431 °
DWR ID	DWR_MA0009_01_f_2015_322				
Comment Code					
S2 : Repair the levee slope damaged by foot traffic and prevent access where possible.					
Inspector Comment

View of the slope stability on the waterward side of the levee looking downstream. Spring 2016.

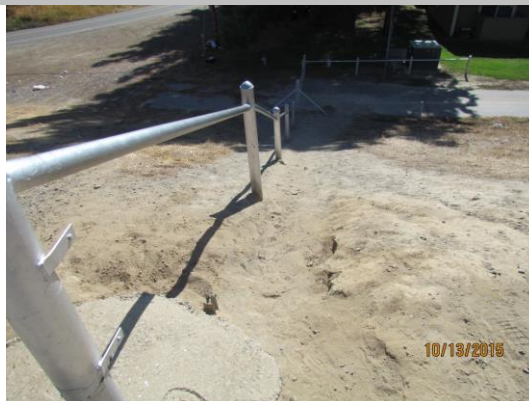
Photo 1 of 2 : SP\_2017\_MA0009\_201\_323\_20170320\_00242.jpg

LM Start	2.40	Rating **	M	Issue No.	323
LM End	2.40	Issue Type +	Ma	Location *	LS
Category	Earthen Levee			GPS Latitude/Longitude	
				Start	End
Item	Slope Stability			38.517131 °	38.517131 °
				-121.527568 °	-121.527568 °
DWR ID	DWR_MA0009_01_f_2015_323				
Comment Code					
S2 : Repair the levee slope damaged by foot traffic and prevent access where possible.					
Inspector Comment

The seems to use the gate rails as hand rails to access the levee. Fall 2015.

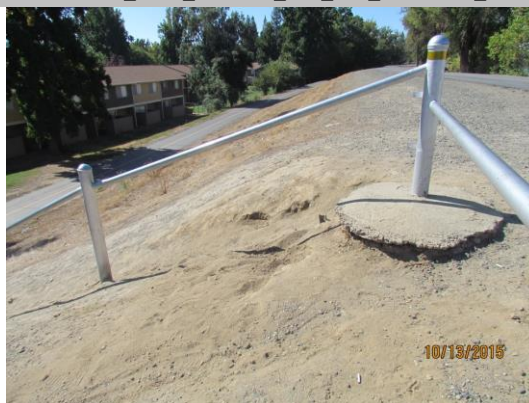
Photo 2 of 2 : SP\_2017\_MA0009\_201\_323\_20170320\_00243.jpg

Perspective view of the the slope stability on the landward side of the levee looking downstream. Fall 2015.

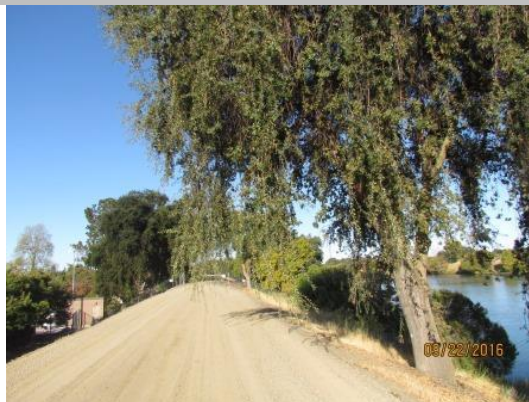
Photo 1 of 1 : SP\_2017\_MA0009\_201\_245\_20170320\_00189.jpg

LM Start	2.72	Rating **	A/W	Issue No.	245
LM End	2.72	Issue Type +	Ma	Location *	CR
Category	Earthen Levee			GPS Latitude/Longitude	
				Start	End
Item	Trim / Thin Trees			38.516271 °	38.516271 °
				-121.533288 °	-121.533288 °
DWR ID	DWR_MA0009_01_f_2016_245				
Comment Code					
T4 : Trim trees over roadway to at least 12 feet above ground level.					
Inspector Comment

View of a tree on WS slope looking downstream. Fall 2016.

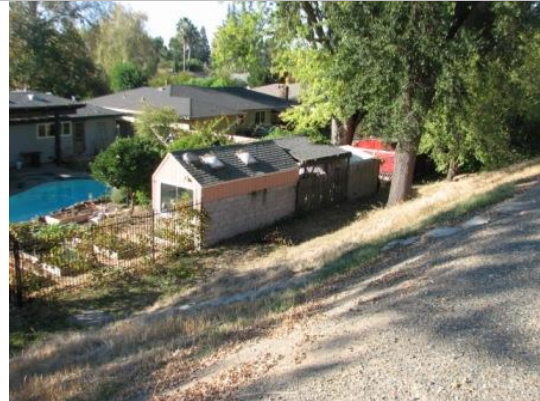
Photo 1 of 1 : SP\_2017\_MA0009\_201\_44\_20170320\_00037.jpg

LM Start	2.78	Rating **	M	Issue No.	44
LM End	2.78	Issue Type +	En	Location *	LS
Category	Earthen Levee			GPS Latitude/Longitude	
				Start	End
Item	Encroachments			38.516188 °	38.516188 °
				-121.534499 °	-121.534499 °
DWR ID	DWR_MA0009_01_s_2012_44				
Comment Code					
FE : Fence					
Inspector Comment

A building and fence within the easement of the levee. Fall 2013

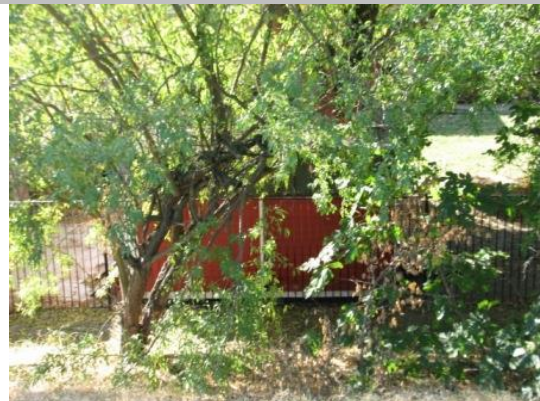
Photo 1 of 1 : SP\_2017\_MA0009\_201\_45\_20170320\_00038.jpg

LM Start	2.79	Rating **	M	Issue No.	45
LM End	2.79	Issue Type +	En	Location *	LS
Category	Earthen Levee			GPS Latitude/Longitude	
				Start	End
Item	Encroachments			38.516187 °	38.516187 °
				-121.534692 °	-121.534692 °
DWR ID	DWR_MA0009_01_s_2012_45				
Comment Code					
BU : Building					
Inspector Comment

The building is within the easement of the levee. Fall 2013

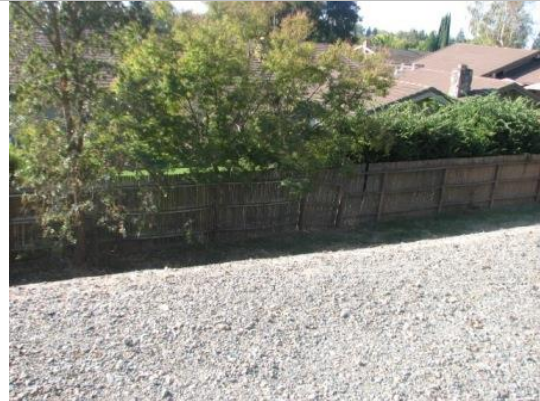
Photo 1 of 1 : SP\_2017\_MA0009\_201\_37\_20170320\_00031.jpg

LM Start	2.91	Rating **	M	Issue No.	37
LM End	2.91	Issue Type +	En	Location *	LS
Category	Earthen Levee			GPS Latitude/Longitude	
				Start	End
Item	Encroachments			38.516070 °	38.516070 °
				-121.536856 °	-121.536856 °
DWR ID	DWR_MA0009_01_f _ 2012_37				
Comment Code					
FE : Fence					
Inspector Comment

A solid board fence is within the easement. Fall 2013

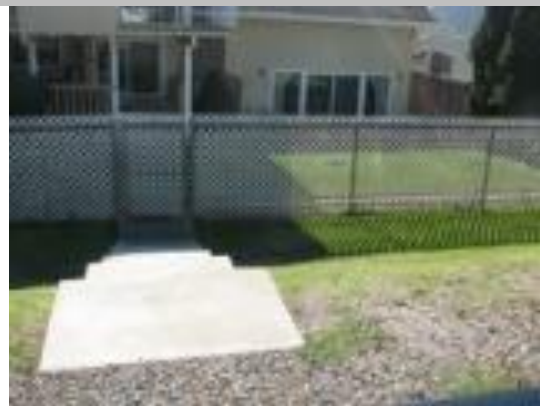
Photo 1 of 1 : SP\_2017\_MA0009\_201\_51\_20170320\_00039.jpg

LM Start	2.94	Rating **	M	Issue No.	51
LM End	2.94	Issue Type +	En	Location *	LS
Category	Earthen Levee			GPS Latitude/Longitude	
				Start	End
Item	Encroachments			38.516025 °	38.516025 °
				-121.537391 °	-121.537391 °
DWR ID	DWR_MA0009_01_s_2017_51				
Comment Code					
ST : Stairway					
Inspector Comment

Steps and landscaping in easement. Fall 2012

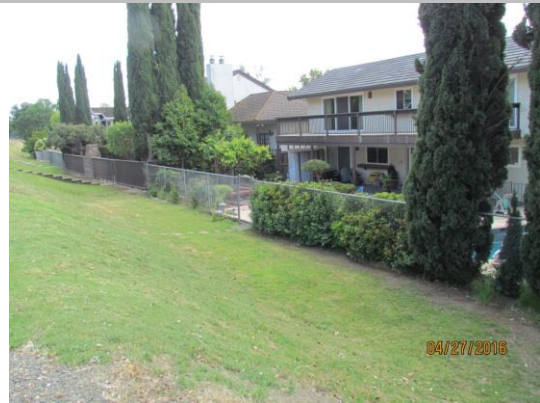
Photo 1 of 1 : SP\_2017\_MA0009\_201\_54\_20170320\_00040.jpg

LM Start	2.97	Rating **	M	Issue No.	54
LM End	2.97	Issue Type +	En	Location *	LS
Category	Earthen Levee			GPS Latitude/Longitude	
				Start	End
Item	Vegetation			38.515954 °	38.515954 °
				-121.537966 °	-121.537966 °
DWR ID	DWR_MA0009_01_s_2012_54				
Comment Code					
V6 : Landscaping					
Inspector Comment					
Bushes and trees block visibility at the toe of the levee.

View of the landscaping planted at the toe of the levee on the landward side looking upstream. Spring 2016.

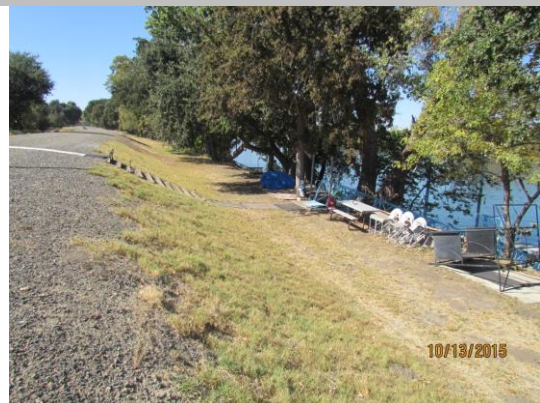
Photo 1 of 1 : SP\_2017\_MA0009\_201\_1768\_20170320\_00303.jpg

LM Start	3.01	Rating **	M	Issue No.	1768
LM End	3.01	Issue Type +	En	Location *	WS
Category	Earthen Levee			GPS Latitude/Longitude	
				Start	End
Item	Encroachments			38.515841 °	38.515841 °
				-121.538710 °	-121.538710 °
DWR ID	DWR_MA0009_01_s_2017_1768				
Comment Code					
FW : Firewood					
Inspector Comment

View of the equipment on the berm of the waterward side looking downstream. Fall 2015.

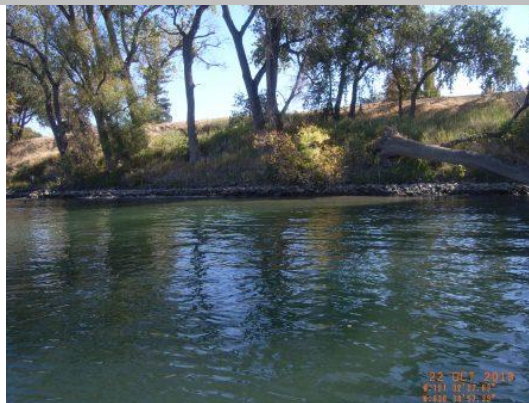
Photo 1 of 2 : SP\_2017\_MA0009\_201\_4\_20170320\_00004.jpg

LM Start	3.09	Rating **	M	Issue No.	4
LM End	3.12	Issue Type +	Ma	Location *	WS
Category	Supplemental			GPS Latitude/Longitude	
				Start	End
Item	2015 USACE Erosion Survey, DRAFT			38.515887 °	38.515794 °
				-121.540174 °	-121.540713 °
DWR ID	DWR_MA0009_01_s_2016_4				
Comment Code					
Inspector Comment					
2010 - Small section of slumping, can be fixed with maintenance.					
2011 - Freshly fallen tree and minor new toe erosion. 2015: No					
observed changes. [2015 Site ID: SAC_52-7_L]

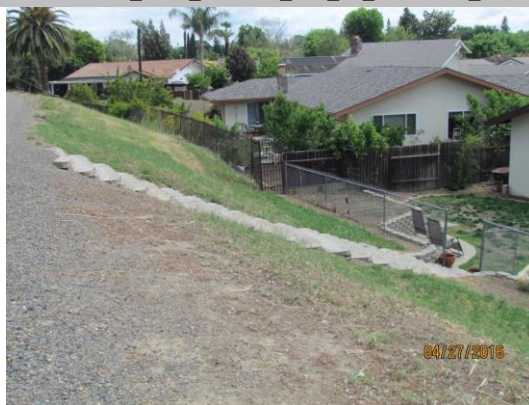
Photo 1 of 1 : SP\_2017\_MA0009\_201\_62\_20170320\_00043.jpg

LM Start	3.12	Rating **	M	Issue No.	62
LM End	3.12	Issue Type +	En	Location *	LS
Category	Earthen Levee			GPS Latitude/Longitude	
				Start	End
Item	Encroachments			38.515481 °	38.515481 °
				-121.540605 °	-121.540605 °
DWR ID	DWR_MA0009_01_s_2012_62				
Comment Code					
RW : Retaining Wall					
Inspector Comment					
Stairs and landscaping are permitted under Permit 18270 and 7525. Retaining wall is an illegal encroachment.

View of the steps on the slope and the retaining wall at the toe of the levee on the landward side looking upstream. Spring 2016.

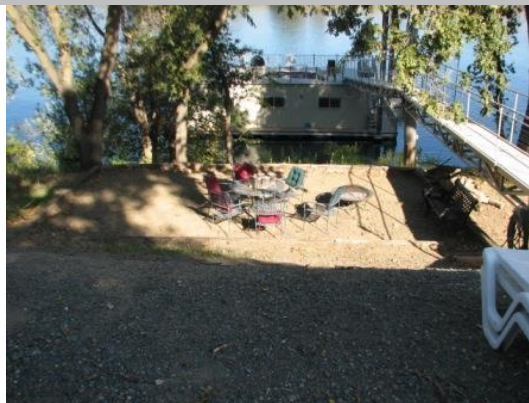
Photo 1 of 1 : SP\_2017\_MA0009\_201\_165\_20170320\_00129.jpg

LM Start	3.18	Rating **	M	Issue No.	165
LM End	3.18	Issue Type +	En	Location *	WS
Category	Earthen Levee			GPS Latitude/Longitude	
				Start	End
Item	Encroachments			38.515257 °	38.515257 °
				-121.541667 °	-121.541667 °
DWR ID	DWR_MA0009_01_s_2013_165				
Comment Code					
EQ : Equipment					
Inspector Comment					
Decomposed patio, tables, and chairs are on the berm of the waterward side of the levee.

A decomposed granite patio is on the berm. Fall 2013

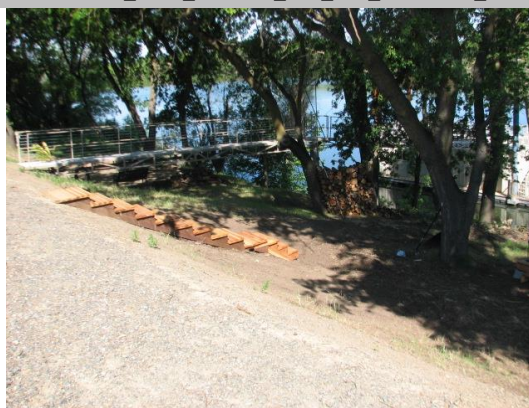
Photo 1 of 3 : SP\_2017\_MA0009\_201\_299\_20170320\_00219.jpg

LM Start	3.18	Rating **	M	Issue No.	299
LM End	3.18	Issue Type +	En	Location *	WS
Category	Earthen Levee			GPS Latitude/Longitude	
				Start	End
Item	Encroachments			38.515255 °	38.515255 °
				-121.541672 °	-121.541672 °
DWR ID	DWR_MA0009_01_s_2014_299				
Comment Code					
ST : Stairway					
Inspector Comment					
Steps, decking plus firewood stacked up. Need to get a permit. Stairway does not have permit but does not inhibit emergency operations.

New steps on the waterside slope. Spring 2014

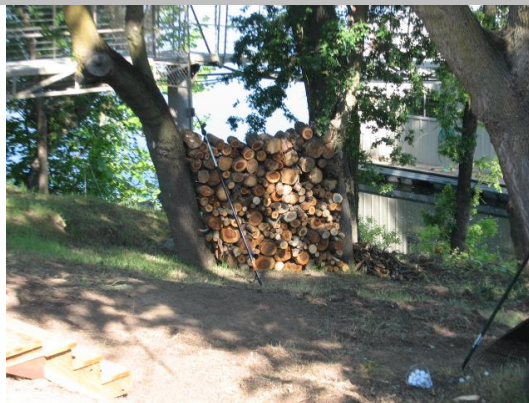
Photo 2 of 3 : SP\_2017\_MA0009\_201\_299\_20170320\_00218.jpg

A large stack of firewood on the waterside berm. Spring 2014

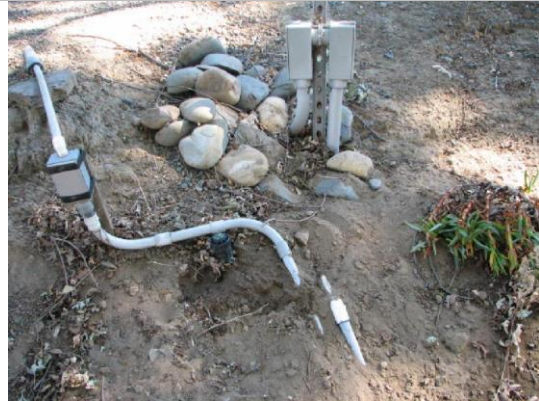
Photo 2 of 2 : UCIP\_SP\_2017\_5860\_8945.jpg

LM Start	3.19	Rating **	M	Issue No.	1787 (cont)	
LM End	3.19	Issue Type +	En	Location *	WS	
Category	Supplemental			GPS Latitude/Longitude		
				Start	End	
Item	DWR UCIP Field Study			38.515210 °	38.515210 °	
				-121.541840 °	-121.541840 °	
DWR ID						
Comment Code						
Inspector Comment						
FS_ID:5860 DS_ID:18909 EP_NO: N/A Repair Type: Non-Urgent Crossing Status: Found UCIP Comments: No permit identified for this crossing. This pipe was not part of the upgrade to the pier/walkway under Permit No. 17904. Nor was it part of the pier before the upgrade. FIELD_STRUCT_DESC: 1.0-inch PVC waterline through the levee, 1.5 feet below the crown. Hosebib attached to downstream side of boat ramp/pier 50-feet upstream from pipe crossing. FS Date: 6/20/2012 10:14:00 AM

Pipes visible on LS slope approximately 50-feet downstream from pier walkway.

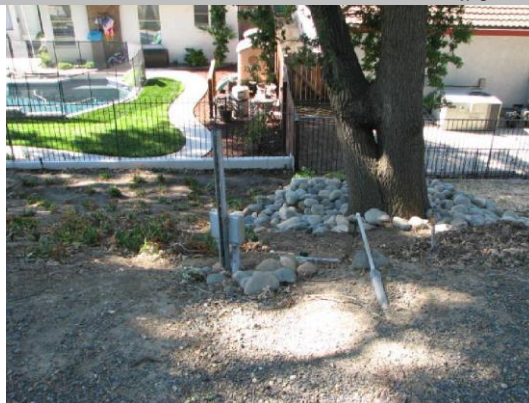
Photo 2 of 2 : UCIP\_SP\_2017\_5854\_8933.jpg

LM Start	3.19	Rating **	M	Issue No.	1789 (cont)	
LM End	3.19	Issue Type +	En	Location *	WS	
Category	Supplemental			GPS Latitude/Longitude		
				Start	End	
Item	DWR UCIP Field Study			38.515230 °	38.515230 °	
				-121.541850 °	-121.541850 °	
DWR ID						
Comment Code						
Inspector Comment						
FS_ID:5854 DS_ID:18908 EP_NO: N/A Repair Type: Non-Urgent Crossing Status: Found UCIP Comments: No permit identified for this crossing. Pipes were not part of permit for upgrade to pier (PN: 17904) nor were they apart of the existing pier previous to this permit. FIELD_STRUCT_DESC: 1.25-inch PVC electric line through the levee, 1.5 feet below the crown. Electric box mounted to post on LS shoulder. FS Date: 6/20/2012 10:02:01 AM

Pipes on LS slope approximately 50-feet downstream from walkway/pier.

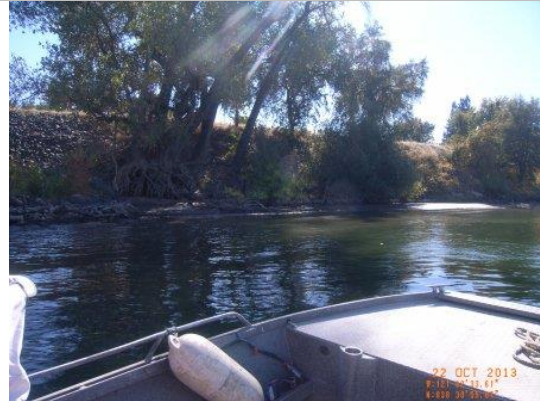
Photo 1 of 2 : SP\_2017\_MA0009\_201\_21\_20170320\_00020.jpg

LM Start	3.24	Rating **	M	Issue No.	21
LM End	3.26	Issue Type +	Ma	Location *	WS
Category	Supplemental			GPS Latitude/Longitude	
				Start	End
Item	2015 USACE Erosion Survey, DRAFT			38.515300 °	38.515184 °
				-121.542755 °	-121.543136 °
DWR ID	DWR_MA0009_01_s_2016_21				
Comment Code					
Inspector Comment					
2004 - A large tree cave was identified. 2005 - Site repaired. 2010 - At the downstream end of the repair at 52.5, bad transition is inducing further erosion. 2011 - Minor new erosion on bank. 2015: No observed changes. [2015 Site ID: SAC_52-4_L]

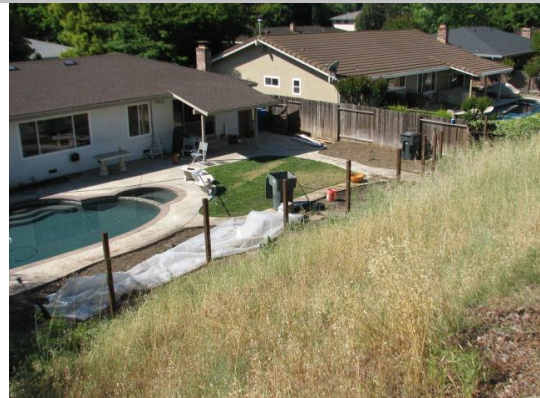
Photo 1 of 3 : SP\_2017\_MA0009\_201\_300\_20170320\_00220.jpg

LM Start	3.25	Rating **	M	Issue No.	300
LM End	3.25	Issue Type +	En	Location *	LS
Category	Earthen Levee			GPS Latitude/Longitude	
				Start	End
Item	Encroachments			38.514995 °	38.514995 °
				-121.542869 °	-121.542869 °
DWR ID	DWR_MA0009_01_s_2014_300				
Comment Code					
FE : Fence					
Inspector Comment

A wooden fence is being installed along the toe of the levee. Spring 2014

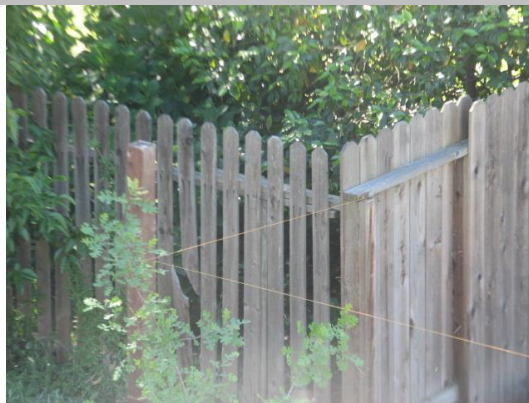
Photo 2 of 3 : SP\_2017\_MA0009\_201\_300\_20170320\_00221.jpg

A new fence is being off set into the levee toe. Spring 2014

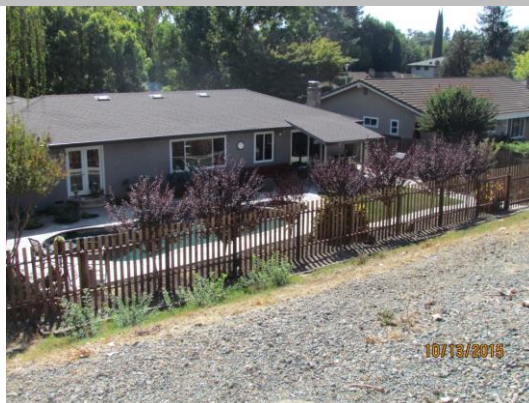
Photo 3 of 3 : SP\_2017\_MA0009\_201\_300\_20170320\_00222.jpg

View of the new fence along the levee toe on the landward side of the levee. Fall 2015.

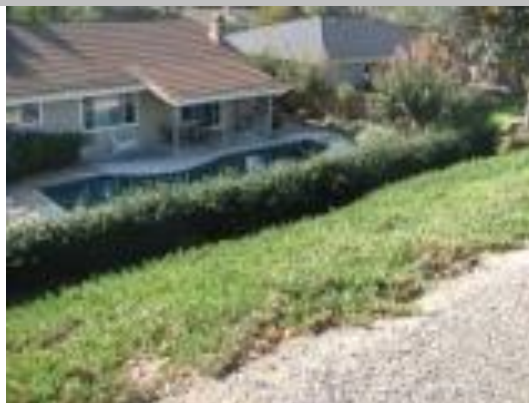
Photo 1 of 1 : SP\_2017\_MA0009\_201\_69\_20170320\_00045.jpg

LM Start	3.25	Rating **	U	Issue No.	69
LM End	3.27	Issue Type +	En	Location *	LS
Category	Earthen Levee			GPS Latitude/Longitude	
				Start	End
Item	Encroachments			38.514973 °	38.514900 °
				-121.542932 °	-121.543217 °
DWR ID	DWR_MA0009_01_s_2012_69				
Comment Code					
FE : Fence					
Inspector Comment

A fence and retaining wall with star jasmine growing on it blocks view of the toe. Fall 2011

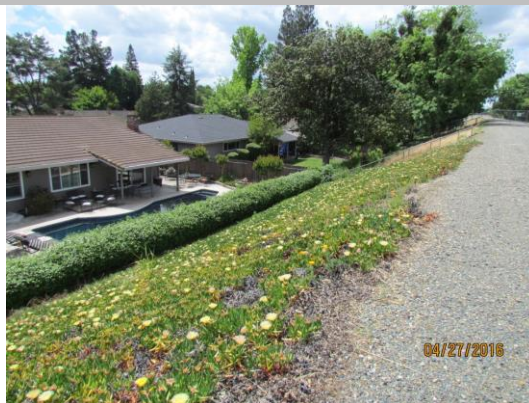
Photo 1 of 1 : SP\_2017\_MA0009\_201\_68\_20170320\_00044.jpg

LM Start	3.25	Rating **	U	Issue No.	68
LM End	3.26	Issue Type +	En	Location *	LS
Category	Earthen Levee			GPS Latitude/Longitude	
				Start	End
Item	Vegetation			38.514957 °	38.514916 °
				-121.542969 °	-121.543148 °
DWR ID	DWR_MA0009_01_s_2012_68				
Comment Code					
V6 : Landscaping					
Inspector Comment					
Ice plants, fence, and steps are permitted by Permit 8108-A and 8108-B. Vegetation on fence blocks visibility.

View of the groundcover and vines growing on the fence on the landward side of the levee looking downstream. Spring 2016.

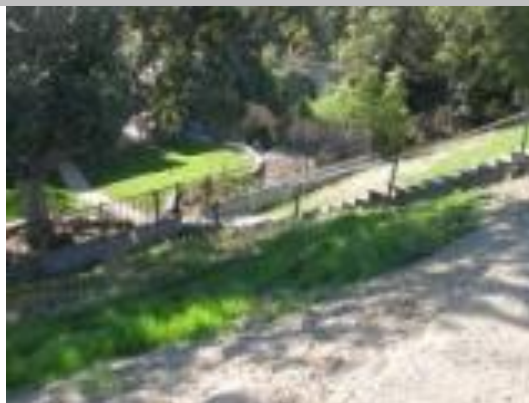
Photo 1 of 2 : SP\_2017\_MA0009\_201\_70\_20170320\_00046.jpg

LM Start	3.27	Rating **	M	Issue No.	70
LM End	3.28	Issue Type +	En	Location *	LS
Category	Earthen Levee			GPS Latitude/Longitude	
				Start	End
Item	Vegetation			38.514899 °	38.514842 °
				-121.543224 °	-121.543444 °
DWR ID	DWR_MA0009_01_s_2012_70				
Comment Code					
V6 : Landscaping					
Inspector Comment					
Stairs are permitted by Permit 12266 but the wall and wrought iron fence are not. Vegetation on fence blocks visibility.

Wall built along toe of levee. Fall 2012

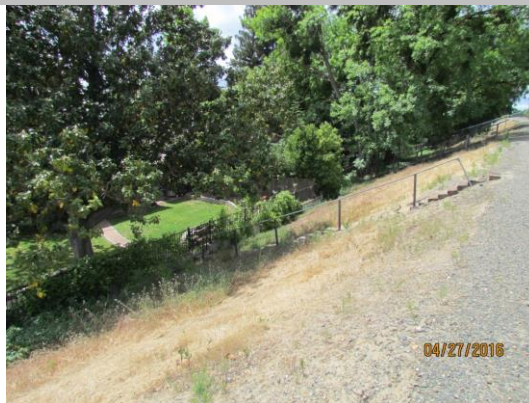
Photo 2 of 2 : SP\_2017\_MA0009\_201\_70\_20170320\_00047.jpg

LM Start	3.27	Rating **	M	Issue No.	70 (cont)	
LM End	3.28	Issue Type +	En	Location *	LS	
Category	Earthen Levee			GPS Latitude/Longitude		
				Start		End
Item	Vegetation			38.514899 °		38.514842 °
				-121.543224 °		-121.543444 °
DWR ID	DWR_MA0009_01_s_2012_70					
Comment Code						
V6 : Landscaping						
Inspector Comment						
Stairs are permitted by Permit 12266 but the wall and wrought iron fence are not. Vegetation on fence blocks visibility.

View of the wall built along the levee toe on the landward side looking downstream. Landscape vegetation is starting to block the wall. Spring 2016.

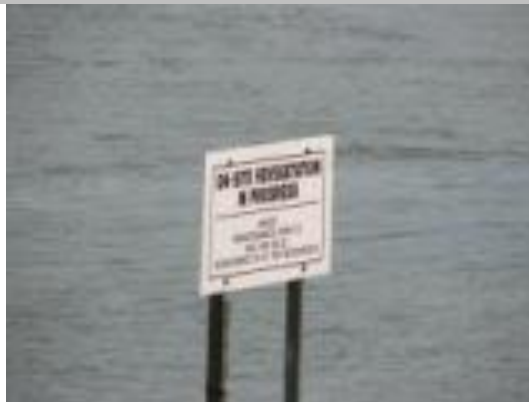
Photo 1 of 2 : SP\_2017\_MA0009\_201\_100\_20170320\_00066.jpg

LM Start	3.30	Rating **	A/W	Issue No.	100
LM End	3.52	Issue Type +	En	Location *	WS
Category	Earthen Levee			GPS Latitude/Longitude	
				Start	End
Item	Vegetation			38.514757 °	38.513647 °
				-121.543781 °	-121.547648 °
DWR ID	DWR_MA0009_01_s_2012_100				
Comment Code					
V8 : Environmental Requirements.					
Inspector Comment

A revegetation site. Photo taken spring 2012.

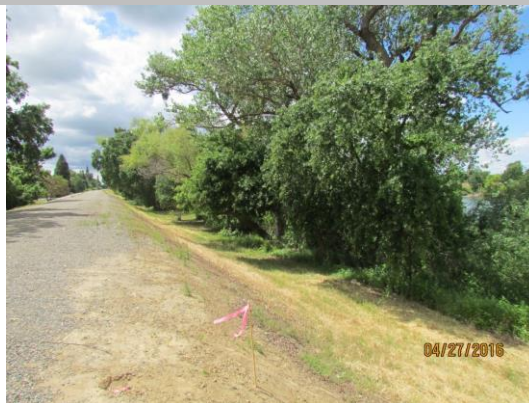
Photo 2 of 2 : SP\_2017\_MA0009\_201\_100\_20170320\_00067.jpg

View of the revegetation site on the berm of the waterward side of the levee looking downstream. Spring 2016.

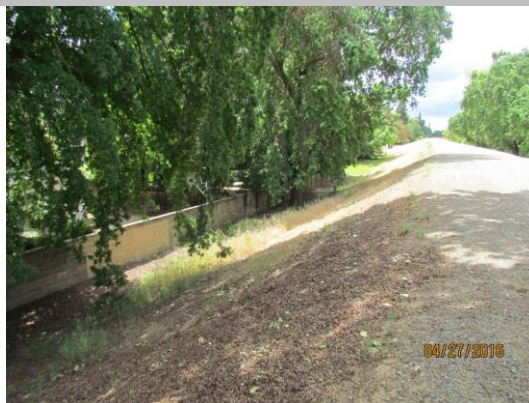
Photo 1 of 1 : SP\_2017\_MA0009\_201\_73\_20170320\_00049.jpg

LM Start	3.31	Rating **	U	Issue No.	73
LM End	3.34	Issue Type +	En	Location *	LS
Category	Earthen Levee			GPS Latitude/Longitude	
				Start	End
Item	Encroachments			38.514718 °	38.514555 °
				-121.543961 °	-121.544552 °
DWR ID	DWR_MA0009_01_s_2012_73				
Comment Code					
FE : Fence					
Inspector Comment

View of the wood and block fence at the toe of the levee on the landward side looking downstream. Spring 2016.

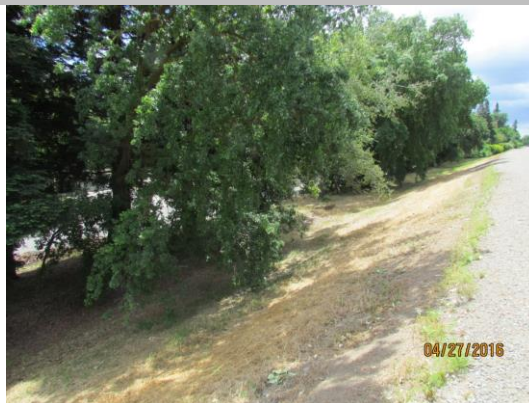
Photo 1 of 1 : SP\_2017\_MA0009\_201\_320\_20170320\_00240.jpg

LM Start	3.46	Rating **	M	Issue No.	320
LM End	3.46	Issue Type +	Ma	Location *	LS
Category	Earthen Levee			GPS Latitude/Longitude	
				Start	End
Item	Trim / Thin Trees			38.513906 °	38.513906 °
				-121.546635 °	-121.546635 °
DWR ID	DWR_MA0009_01_s _ 2016_320				
Comment Code					
T1 : Trim trees to at least five feet above ground level.					
Inspector Comment

View of the tree on the landward side of the levee looking downstream. Spring 2016.

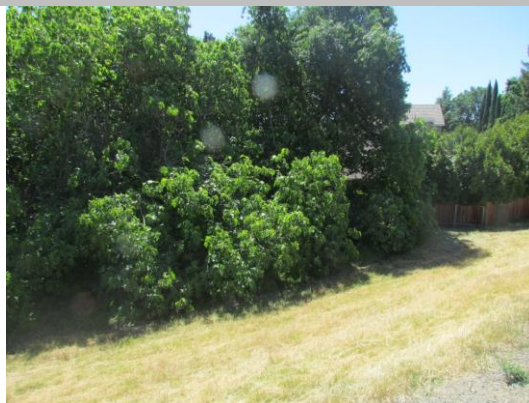
Photo 1 of 1 : SP\_2017\_MA0009\_201\_297\_20170320\_00216.jpg

LM Start	3.56	Rating **	M	Issue No.	297	
LM End	3.56	Issue Type +	Ma	Location *	LS	
Category	Earthen Levee			GPS Latitude/Longitude		
				Start		End
Item	Trim / Thin Trees			38.513447 °		38.513447 °
				-121.548329 °		-121.548329 °
DWR ID	DWR_MA0009_01_s _ 2015_297					
Comment Code						
T2 : Thin trees to allow visibility of the ground and room to flood fight.						
Inspector Comment						
Trees need to be thinned and trimmed for visibility.

View of the landscaping tree on the landward side of the levee looking downstream. Spring 2015.

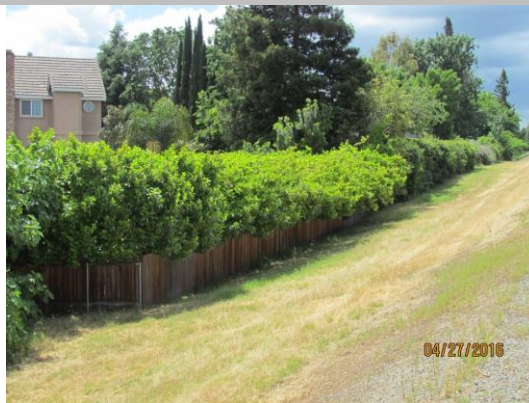
Photo 1 of 1 : SP\_2017\_MA0009\_201\_74\_20170320\_00050.jpg

LM Start	3.57	Rating **	U	Issue No.	74
LM End	3.59	Issue Type +	En	Location *	LS
Category	Earthen Levee			GPS Latitude/Longitude	
				Start	End
Item	Encroachments			38.513416 °	38.513337 °
				-121.548463 °	-121.548820 °
DWR ID	DWR_MA0009_01_s_2012_74				
Comment Code					
FE : Fence					
Inspector Comment

View of the wooden fence and tall shrubs at the toe of the levee on the landward side of the levee looking downstream. Spring 2016.

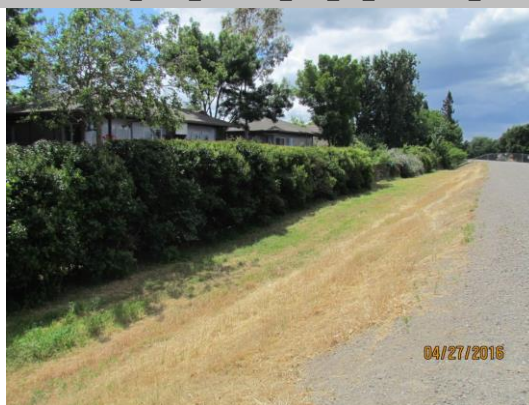
Photo 1 of 1 : SP\_2017\_MA0009\_201\_75\_20170320\_00051.jpg

LM Start	3.59	Rating **	U	Issue No.	75
LM End	3.61	Issue Type +	En	Location *	LS
Category	Earthen Levee			GPS Latitude/Longitude	
				Start	End
Item	Vegetation			38.513330 °	38.513236 °
				-121.548838 °	-121.549264 °
DWR ID	DWR_MA0009_01_s_2012_75				
Comment Code					
V6 : Landscaping					
Inspector Comment					
The hedges blocks the view of the levee berm.

View of the hedge on the berm of the levee on the landward side looking downstream. Spring 2016.

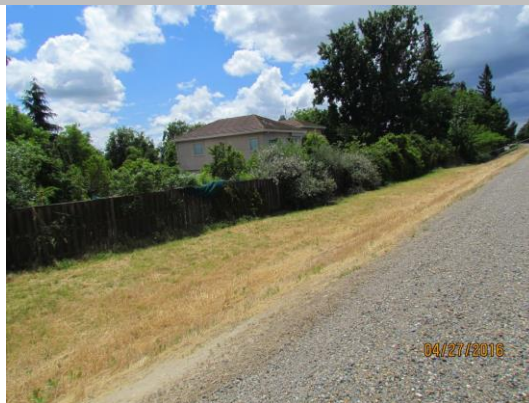
Photo 1 of 1 : SP\_2017\_MA0009\_201\_76\_20170320\_00052.jpg

LM Start	3.61	Rating **	U	Issue No.	76
LM End	3.66	Issue Type +	En	Location *	LS
Category	Earthen Levee			GPS Latitude/Longitude	
				Start	End
Item	Encroachments			38.513236 °	38.513064 °
				-121.549265 °	-121.550000 °
DWR ID	DWR_MA0009_01_s_2012_76				
Comment Code					
FE : Fence					
Inspector Comment

View of the wooden fence on the landward side of the levee looking downstream. Spring 2016.

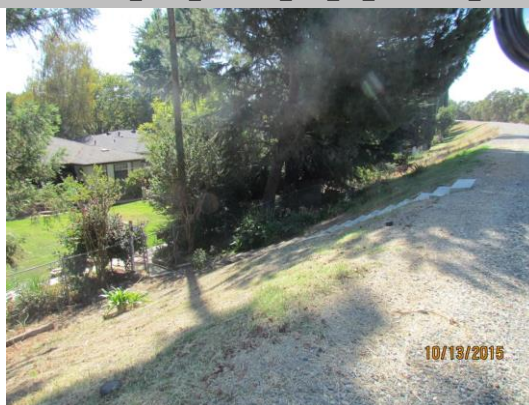
Photo 1 of 1 : SP\_2017\_MA0009\_201\_79\_20170320\_00053.jpg

LM Start	3.69	Rating **	M	Issue No.	79
LM End	3.69	Issue Type +	En	Location *	LS
Category	Earthen Levee			GPS Latitude/Longitude	
				Start	End
Item	Vegetation			38.512866 °	38.512866 °
				-121.550585 °	-121.550585 °
DWR ID	DWR_MA0009_01_s_2012_79				
Comment Code					
V6 : Landscaping					
Inspector Comment					
Trees need to be trimmed at least 5 feet above ground for visibility.

View of the landscaping tree on the landward side of the levee looking downstream. Fall 2015.

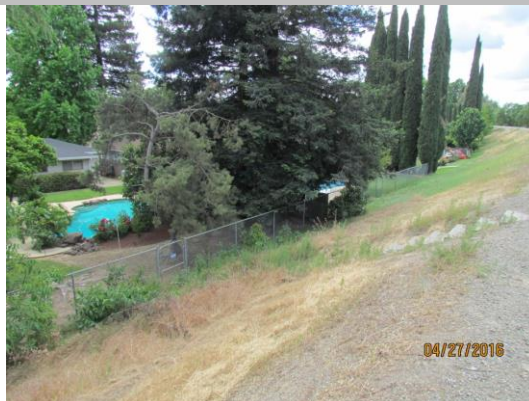
Photo 1 of 1 : SP\_2017\_MA0009\_201\_80\_20170320\_00054.jpg

LM Start	3.71	Rating **	M	Issue No.	80
LM End	3.71	Issue Type +	En	Location *	LS
Category	Earthen Levee			GPS Latitude/Longitude	
				Start	End
Item	Vegetation			38.512753 °	38.512753 °
				-121.550856 °	-121.550856 °
DWR ID	DWR_MA0009_01_s _ 2012_80				
Comment Code					
V6 : Landscaping					
Inspector Comment					
Trees need to be thinned and trimmed for visibility.

View of the fence and trees on the landward side of the levee looking downstream. Spring 2016.

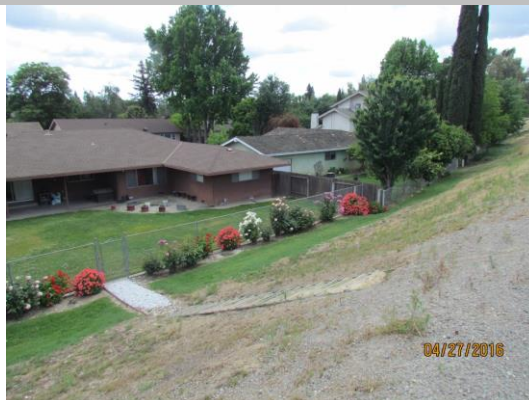
Photo 1 of 1 : SP\_2017\_MA0009\_201\_82\_20170320\_00055.jpg

LM Start	3.74	Rating **	M	Issue No.	82
LM End	3.74	Issue Type +	En	Location *	LS
Category	Earthen Levee			GPS Latitude/Longitude	
				Start	End
Item	Encroachments			38.512507 °	38.512507 °
				-121.551334 °	-121.551334 °
DWR ID	DWR_MA0009_01_s _ 2012_82				
Comment Code					
ST : Stairway					
Inspector Comment					
Steps are not permitted.

View of the steps and landscaping at the toe of the levee on the landward side looking downstream. Spring 2016.

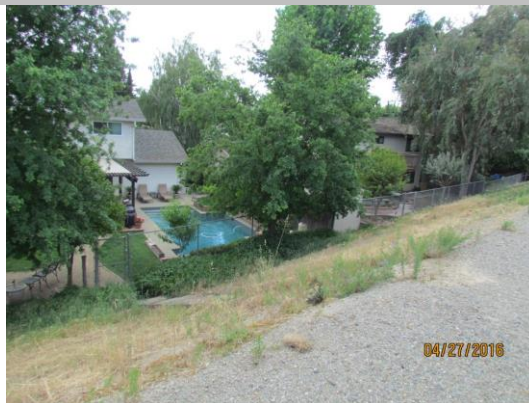
Photo 1 of 1 : SP\_2017\_MA0009\_201\_84\_20170320\_00056.jpg

LM Start	3.77	Rating **	M	Issue No.	84
LM End	3.77	Issue Type +	En	Location *	LS
Category	Earthen Levee			GPS Latitude/Longitude	
				Start	End
Item	Vegetation			38.512221 °	38.512221 °
				-121.551793 °	-121.551793 °
DWR ID	DWR_MA0009_01_s_2012_84				
Comment Code					
V6 : Landscaping					
Inspector Comment					
Landscaping bushes at the toe of the levee blocks visibility.

View of the landscaping at the toe of the levee on the landward side. Spring 2016.

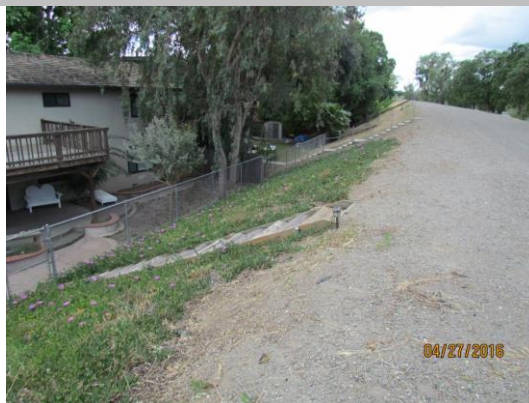
Photo 1 of 1 : SP\_2017\_MA0009\_201\_85\_20170320\_00057.jpg

LM Start	3.78	Rating **	M	Issue No.	85
LM End	3.78	Issue Type +	En	Location *	LS
Category	Earthen Levee			GPS Latitude/Longitude	
				Start	End
Item	Vegetation			38.512090 °	38.512090 °
				-121.551958 °	-121.551958 °
DWR ID	DWR_MA0009_01_s_2012_85				
Comment Code					
V6 : Landscaping					
Inspector Comment					
Fence and stairs are permitted by Permit 12169 and 12169-A. Groundcover does not seem to be permitted and blocks visibility on the slope.

View of the groundcover on the landward side of the levee looking downstream. Spring 2016.

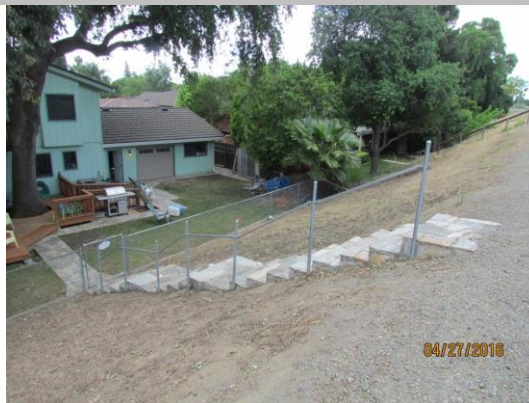
Photo 1 of 1 : SP\_2017\_MA0009\_201\_86\_20170320\_00058.jpg

LM Start	3.80	Rating **	M	Issue No.	86
LM End	3.80	Issue Type +	En	Location *	LS
Category	Earthen Levee			GPS Latitude/Longitude	
				Start	End
Item	Encroachments			38.511954 °	38.511954 °
				-121.552136 °	-121.552136 °
DWR ID	DWR_MA0009_01_s_2012_86				
Comment Code					
ST : Stairway					
Inspector Comment					
Cannot find a permit regarding the steps and fence.

View of the handrail and steps on the landward side of the levee looking downstream. Spring 2016.

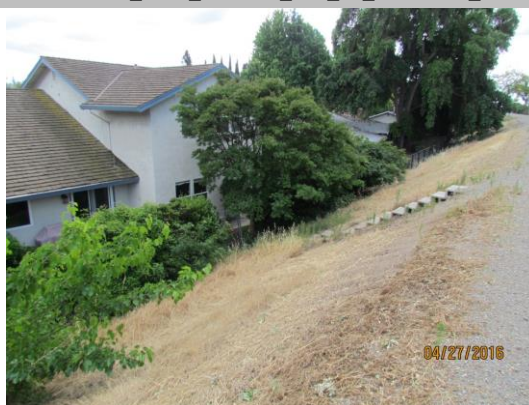
Photo 1 of 1 : SP\_2017\_MA0009\_201\_88\_20170320\_00059.jpg

LM Start	3.83	Rating **	M	Issue No.	88
LM End	3.83	Issue Type +	En	Location *	LS
Category	Earthen Levee			GPS Latitude/Longitude	
				Start	End
Item	Vegetation			38.511605 °	38.511605 °
				-121.552533 °	-121.552533 °
DWR ID	DWR_MA0009_01_s_2012_88				
Comment Code					
V6 : Landscaping					
Inspector Comment					
The fence and steps are permitted through Permit 12408-A. Vegetation is on the fence and blocks visibility.

View of the landscaping at the toe of the levee on the landward side of the levee looking downstream. Spring 2016.

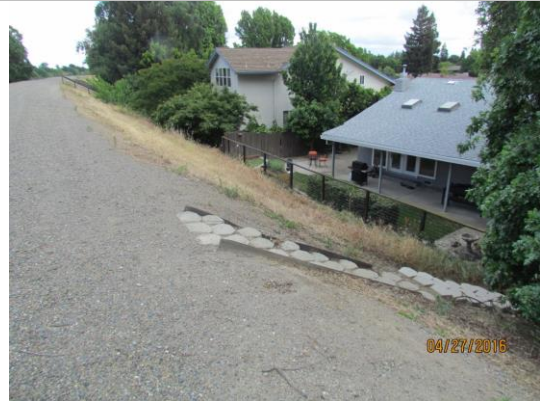
Photo 1 of 1 : SP\_2017\_MA0009\_201\_89\_20170320\_00060.jpg

LM Start	3.85	Rating **	M	Issue No.	89
LM End	3.85	Issue Type +	En	Location *	LS
Category	Earthen Levee			GPS Latitude/Longitude	
				Start	End
Item	Encroachments			38.511372 °	38.511372 °
				-121.552767 °	-121.552767 °
DWR ID	DWR_MA0009_01_s_2012_89				
Comment Code					
ST : Stairway					
Inspector Comment					
Timber stairs are permitted through Permit 11977-B, but these stairs are concrete.

View of the steps on the landward side of the levee looking upstream. Spring 2016.

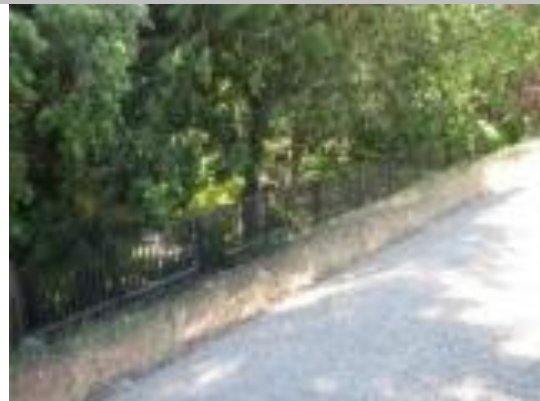
Photo 1 of 1 : SP\_2017\_MA0009\_201\_90\_20170320\_00061.jpg

LM Start	3.86	Rating **	M	Issue No.	90
LM End	3.86	Issue Type +	En	Location *	LS
Category	Earthen Levee			GPS Latitude/Longitude	
				Start	End
Item	Encroachments			38.511219 °	38.511219 °
				-121.552907 °	-121.552907 °
DWR ID	DWR_MA0009_01_s_2012_90				
Comment Code					
FE : Fence					
Inspector Comment					
Permit (7334-A) states the fence to be a solid board fence with every other 3 inch board strips removed for visibility. Current fence is wrought iron and not in compliance with existing permit.

Wooden fence and landscape at toe. Spring 2013

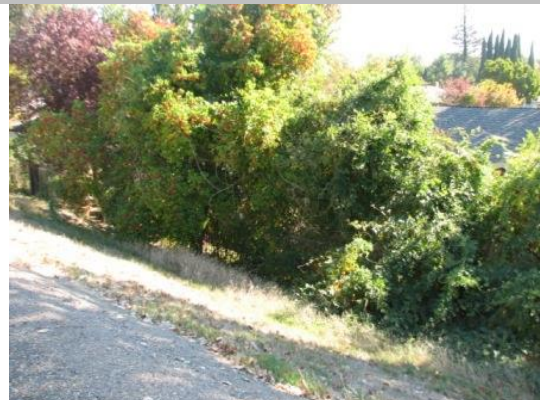
Photo 1 of 1 : SP\_2017\_MA0009\_201\_91\_20170320\_00062.jpg

LM Start	3.88	Rating **	M	Issue No.	91
LM End	3.88	Issue Type +	En	Location *	LS
Category	Earthen Levee			GPS Latitude/Longitude	
				Start	End
Item	Vegetation			38.511050 °	38.511050 °
				-121.553067 °	-121.553067 °
DWR ID	DWR_MA0009_01_s_2012_91				
Comment Code					
V6 : Landscaping					
Inspector Comment					
Tree needs to be thinned and trimmed for visibility.

Overgrown vegetation blocks visibility. Fall 2013

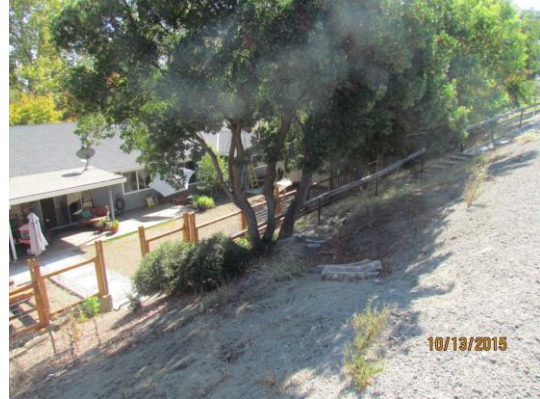
Photo 1 of 1 : SP\_2017\_MA0009\_201\_95\_20170320\_00063.jpg

LM Start	3.93	Rating **	M	Issue No.	95
LM End	3.93	Issue Type +	En	Location *	LS
Category	Earthen Levee			GPS Latitude/Longitude	
				Start	End
Item	Encroachments			38.510438 °	38.510438 °
				-121.553569 °	-121.553569 °
DWR ID	DWR_MA0009_01_s _ 2012_95				
Comment Code					
FE : Fence					
Inspector Comment					
Permit 11748 covers a wrought iron fence. It seems the wrought iron fence has been replaced with a wooden see through fence.

View of the new fence at the toe of the levee on the landward side. Fall 2015.

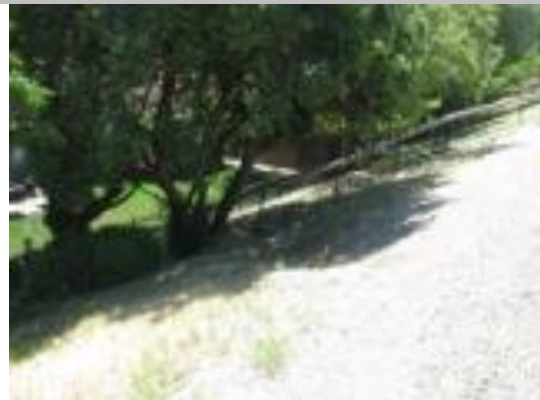
Photo 1 of 1 : SP\_2017\_MA0009\_201\_191\_20170320\_00157.jpg

LM Start	3.93	Rating **	M	Issue No.	191
LM End	3.93	Issue Type +	En	Location *	LS
Category	Earthen Levee			GPS Latitude/Longitude	
				Start	End
Item	Encroachments			38.510343 °	38.510343 °
				-121.553632 °	-121.553632 °
DWR ID	DWR_MA0009_01_s _ 2013_191				
Comment Code					
FE : Fence					
Inspector Comment					
No permit on the stairs.

A new set of stairs with a handrail on the levee. Spring 2013

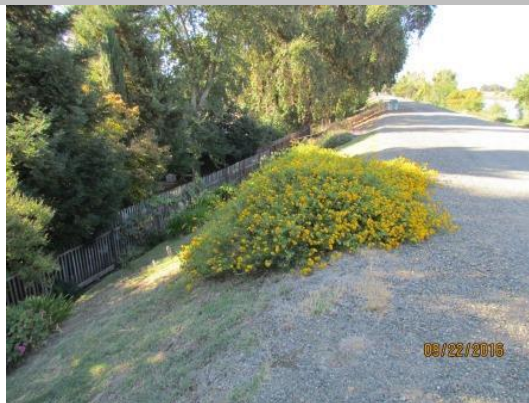
Photo 1 of 1 : SP\_2017\_MA0009\_201\_246\_20170320\_00190.jpg

LM Start	3.94	Rating **	M	Issue No.	246
LM End	3.94	Issue Type +	En	Location *	LS
Category	Earthen Levee			GPS Latitude/Longitude	
				Start	End
Item	Vegetation			38.510207 °	38.510207 °
				-121.553730 °	-121.553730 °
DWR ID	DWR_MA0009_01_f _ 2016_246				
Comment Code					
V6 : Landscaping					
Inspector Comment

View of vegetation on LS slope and crown. Fall 2016.

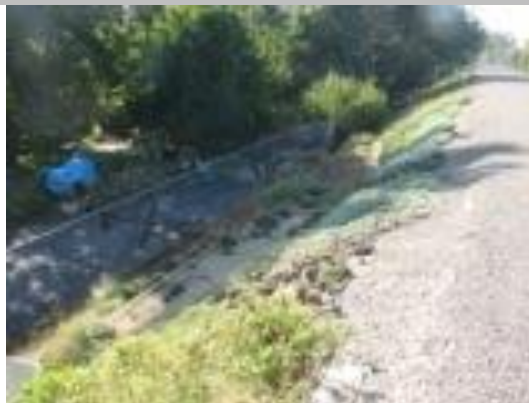
Photo 1 of 2 : SP\_2017\_MA0009\_201\_102\_20170320\_00068.jpg

LM Start	4.01	Rating **	M	Issue No.	102
LM End	4.01	Issue Type +	En	Location *	LS
Category	Earthen Levee			GPS Latitude/Longitude	
				Start	End
Item	Encroachments			38.509343 °	38.509343 °
				-121.554234 °	-121.554234 °
DWR ID	DWR_MA0009_01_s_2012_102				
Comment Code					
RW : Retaining Wall					
Inspector Comment					
Retaining wall is not permitted and located at the toe of the levee.

The homeowner has planted groundcover and installed retaining walls.  
Fall 2011

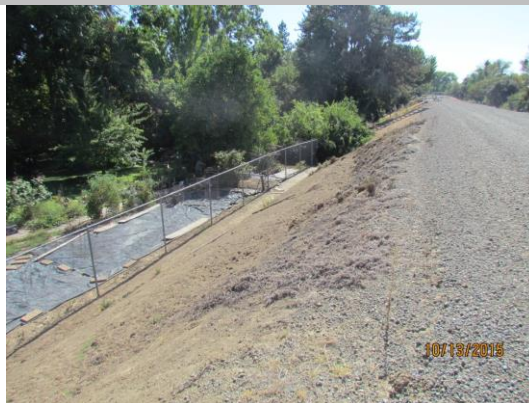
Photo 2 of 2 : SP\_2017\_MA0009\_201\_102\_20170320\_00069.jpg

LM Start	4.01	Rating **	M	Issue No.	102 (cont)	
LM End	4.01	Issue Type +	En	Location *	LS	
Category	Earthen Levee			GPS Latitude/Longitude		
				Start	End	
Item	Encroachments			38.509343 °	38.509343 °	
				-121.554234 °	-121.554234 °	
DWR ID	DWR_MA0009_01_s_2012_102					
Comment Code						
RW : Retaining Wall						
Inspector Comment						
Retaining wall is not permitted and located at the toe of the levee.

View of the retaining wall at the toe of the levee looking downstream.  
Groundcover has been removed. Fall 2015.

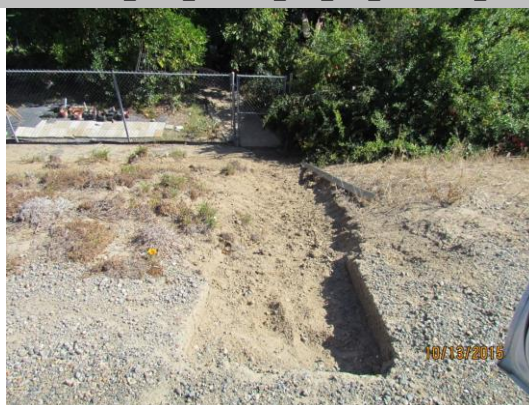
Photo 1 of 2 : SP\_2017\_MA0009\_201\_325\_20170320\_00244.jpg

LM Start	4.02	Rating **	U	Issue No.	325
LM End	4.02	Issue Type +	En	Location *	LS
Category	Earthen Levee			GPS Latitude/Longitude	
				Start	End
Item	Encroachments			38.509205 °	38.509205 °
				-121.554293 °	-121.554293 °
DWR ID	DWR_MA0009_01_f_2015_325				
Comment Code					
ST : Stairway					
Inspector Comment					
There appear to be a project for stairs on the landward slope.

The owner has cut into the levee slope to for stairs. Fall 2015.

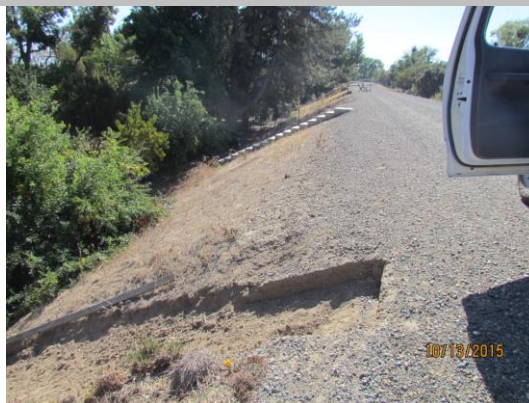
Photo 2 of 2 : SP\_2017\_MA0009\_201\_325\_20170320\_00245.jpg

View of the excavated slope on the landward side of the levee looking downstream. Fall 2015.
